## SICHERHEITSMITTEILUNG für Gurtzeuge

- herausgegeben: 15.03.2013
- Nummer: 02/2013
- Bezug: SERVICE BULLETIN # SPSB 008 Sun Path
- Betroffene Muster: Javelin-Gurtzeuge hergestellt von Jan 2009 bis Febr. 2013

# SERVICE BULLETIN SPSB008

SUBJECT: RELEASE CABLE TRIMMING

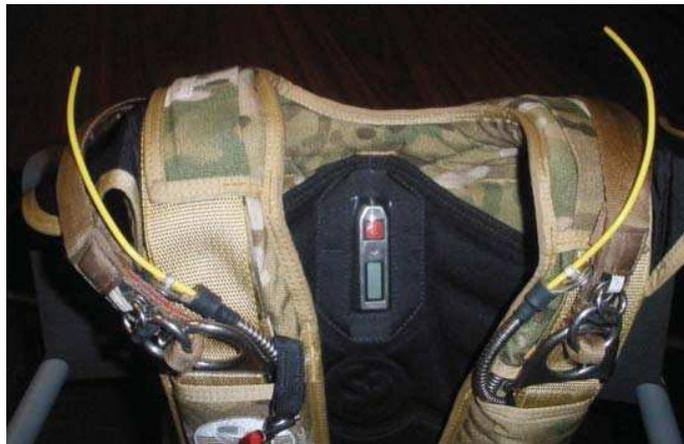
1. Open the main riser covers, locate and remove the excess yellow cable from the main riser tubes on both left and right main risers. Keep the Type IIa securing loop assembled and remove the snap shackle from the riser RSL ring. *(Disengaging the RSL is merely to clear the working area and will need to be reinstalled after inspection)*

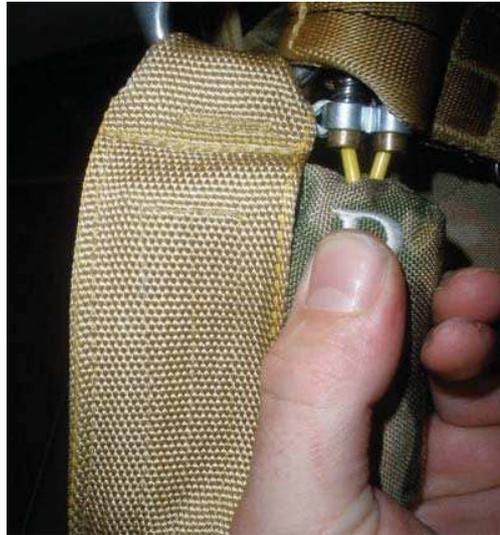
2. Ensure that the release handle is installed; Velcro mated and is all the way up to the top of the inside of the pocket.

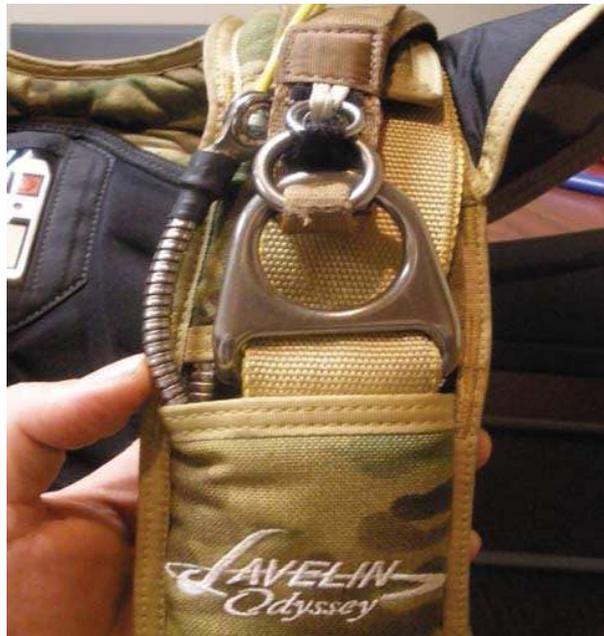
3. Remove any slack in the cables by pulling upward on both sides slightly. (A short tug/or pull on the cable end should take out any slack that may be in the system)
4. Place the rig on the ground or chair and allow the yoke area to relax and ensure your housings are seated/routed as if being worn. Specifically the loop area on the left side behind the main ring cover.

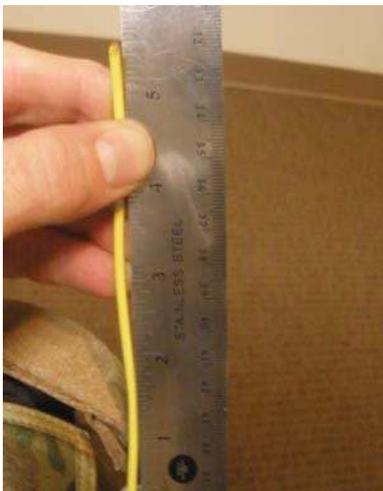
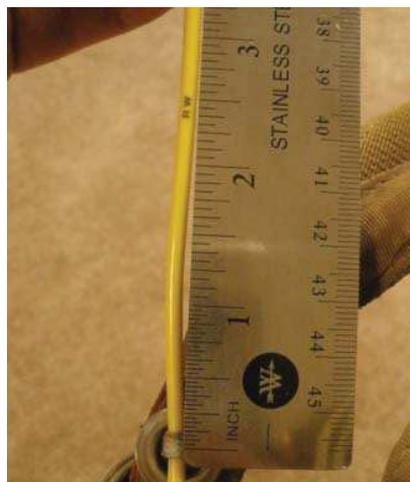
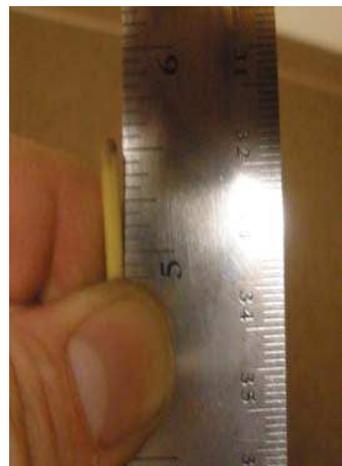
5. NON RSL RISER: Place a ruler with the 0 (zero) at the center point of the grommet on the end of the housing with the numbers running up towards the cable end.
6. Lay the cable out flat against the ruler and record dimension from center of grommet to the end of the cable. Record your measurement and riser side (NON RSL = XX).

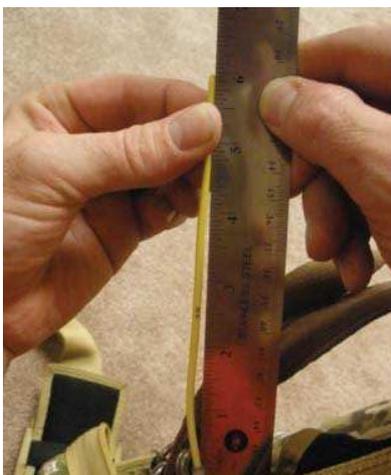
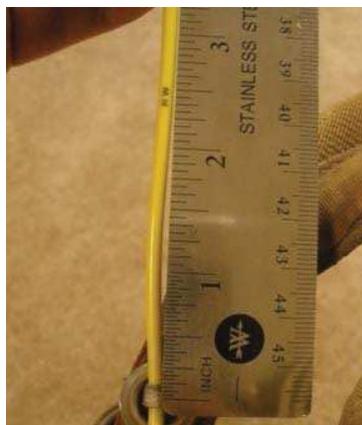
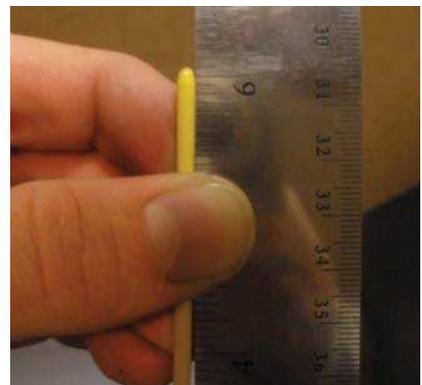
7. RSL RISER: Place a ruler with the 0 (zero) at the center point of the grommet on the end of the housing with the numbers running up towards the cable end.
8. Lay the cable out flat against the ruler and record dimension from center of grommet to the end of the cable. Record your measurement and riser side (RSL = XX).
