SICHERHEITSMITTEILUNG für Gurtzeuge

Nummer: 04/2009

Bezug: Service Bulletin für ICON S7, S8 and S9 Student –Rigs von Aerodyne

Subject: Service Bulletin for Icon S7, S8 and S9 Student rigs

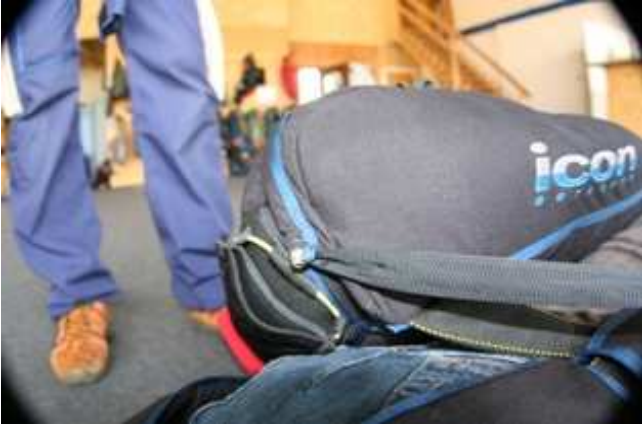
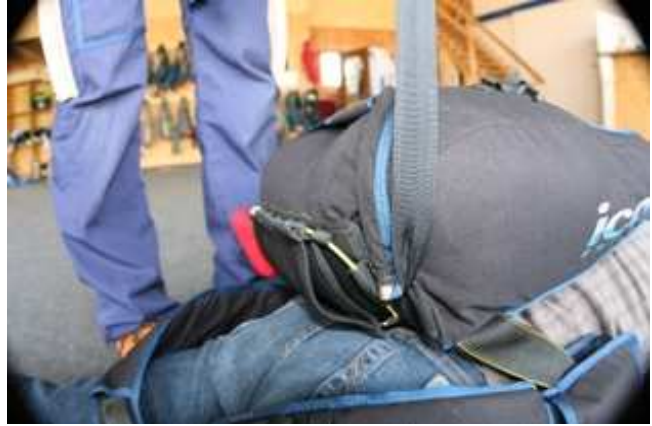
The following pictures demonstrate the problem.

On deployment, it is possible for the bridle to catch on the housing.

This problem is fixed by extending the fabric over the cable housing.
