SICHERHEITSMITTEILUNG
für Tandemgurtzeuge

Nummer: 05/2009

Betrifft: ein möglicher Bruch des unteren Bridle am Droque beim Tandem Atom 740-1

**COMMISSION SECURITE
CIRCULAIRE DE SECURITE N°170**

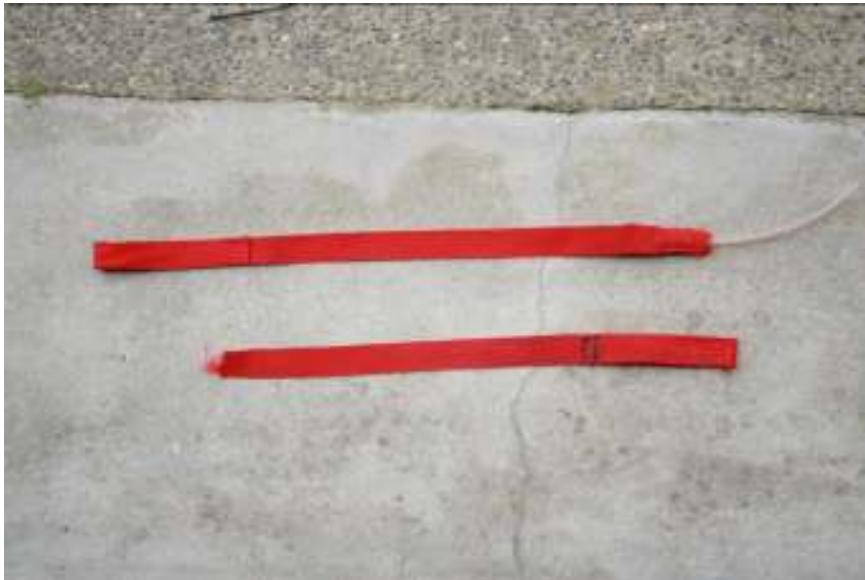
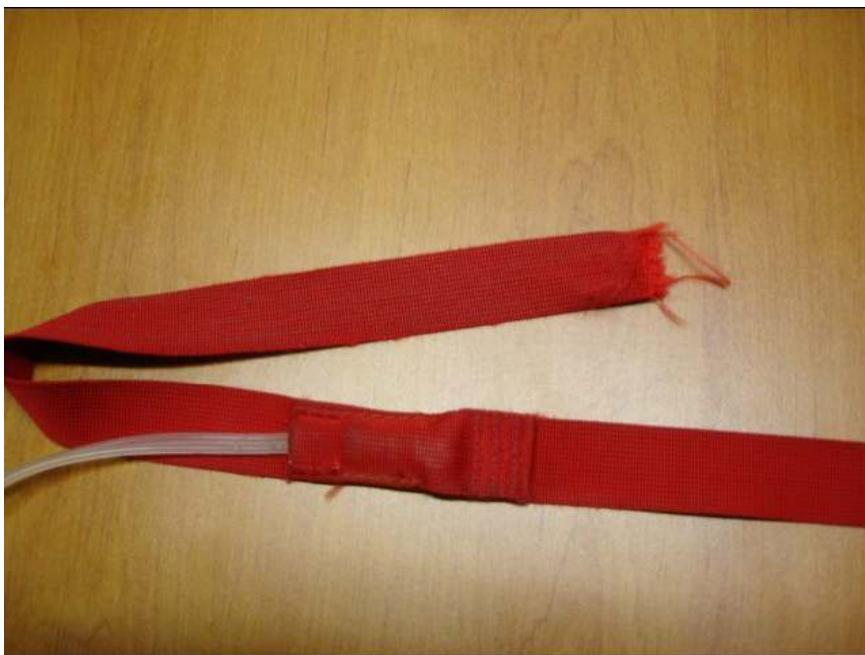
- 1) The bridle failed at the larks-head knot on the outlet side of the main deployment bag by wear and abrasion of the bridle against the ground and/or between the bridle and the right side flap of the deployment bag
- 2) The total failure of the bridle can occur following a fast deployment at the time of the drogue release.
- 3) The failure can happen where the two flexible pins are attached to the drogue by embrittlement of the drogue bridle caused by the repeated folding at the same place during packing.
- 4) In at least one case, no explanation was found for the bridle failure.

Following these reports, the manufacturer, Aerazur, **developed and tested a new product** with twice the tensile strength of these earlier **drogues** bridles (900 kg instead of 450 kg).

- If you note any wear or the start, however small, of a tear or stitching failure
 - on the larks-head knot on the outlet side of the main deployment bag,

- or anywhere along the length of the bridle,
 - the bridle **must** be immediately replaced before the next jump.
- If the bridle does not present any signs of wear or weakness, it must still be replaced -
- if it has more than 200 jumps
 - at the latest by August 15, 2009

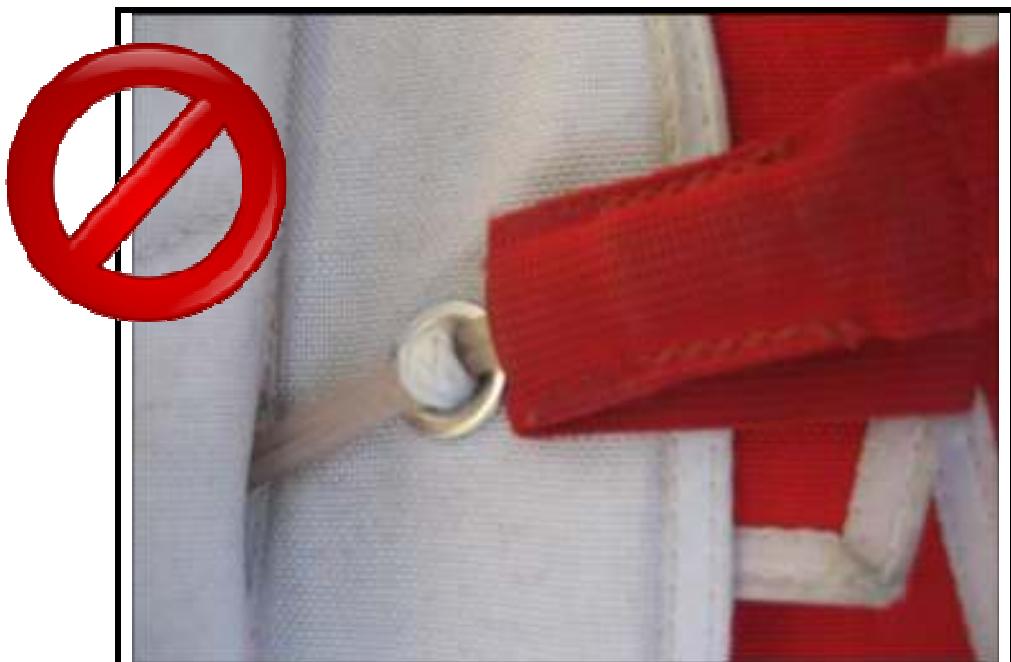
Please note: The engagement of the flexible pins into the tunnel-guide with the pins butted hard against the closing loop can cause an excessive loading and **IS an error of packing on the equipment Atom tandem**
